Uniform Mitigation Verification Inspection Form

Inspection Date: 02/12/2020		
Owner Information		
Owner Name: Curlew Landings Homeowners Association, Inc.		Contact Person:
Address: 514 518 522 526 530 534 Walden Ct		Home Phone:
City: Dunedin	Zip: 34698	Work Phone:
County: Pinellas		Cell Phone:
Insurance Company:		Policy #:
Year of Home: 1990	# of Stories: 3	Email:

Wind Mitigation Photos

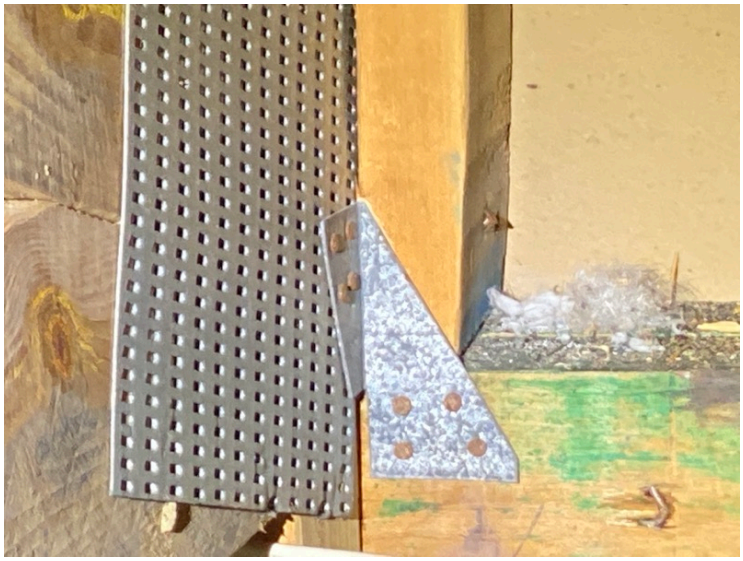
- ☒ B. Clips
     - ☒ Metal connectors that do not wrap over the top of the truss/rafter, **or**
     - ☐ Metal connectors with a minimum of 1 strap that wraps over the top of the truss/rafter and does not meet the nail position requirements of C or D, but is secured with a minimum of 3 nails.

Roof To Wall Connection
